NATIONAL TRANSPORTATION SAFETY BOARD

FIRE INVESTIGATION FACTUAL REPORT

Report No. 13-014

Place : Boston, MA
Date : 1/7/2013
Vehicle : Boeing B787, JA829J
NTSB No. : DCA13IA037
Investigator : David Helson

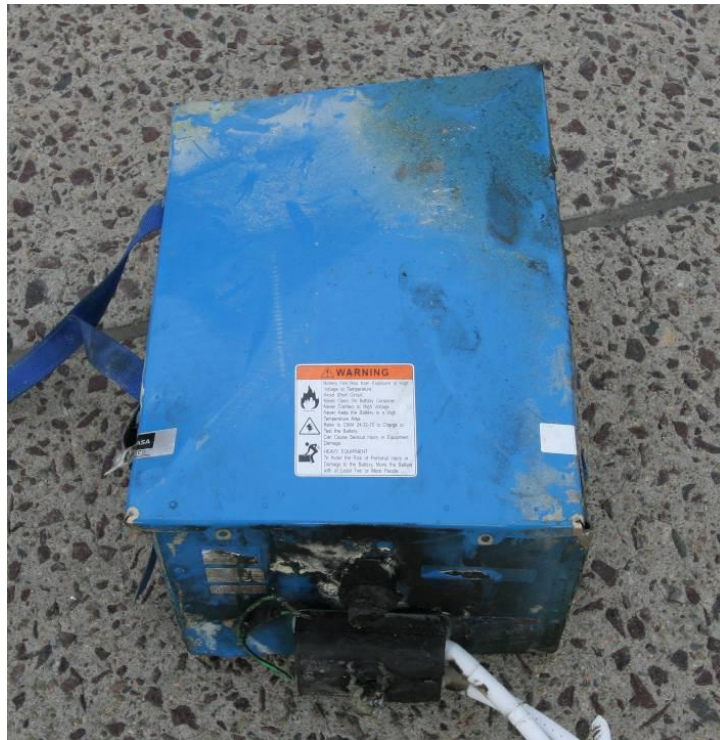
The battery box lid (Figure 1) had a bulged appearance and was creased from corner to corner, resulting in an “X” crease pattern. The corners of the lid, by construction, were not sealed but instead butted up to each other. Due to the bulging and deformation of the lid, the corners had spread, leaving a small gap (Figure 2). The right rear corner of the lid exhibited more soot/charring/residue than the rest of the lid. The lid gasket was largely consumed, with a 5-inch piece remaining. Residue tracks on the external sides of the battery box indicate liquid dripping down the sides from lid/box interface and, in particular, the corners. The lid screw eyelets (tabs) pulled out on the sides and back, but remained intact on the front. The front two screws were removed by the fire department’s responders.

Figure 1: Top down view of battery assembly with lid in place.

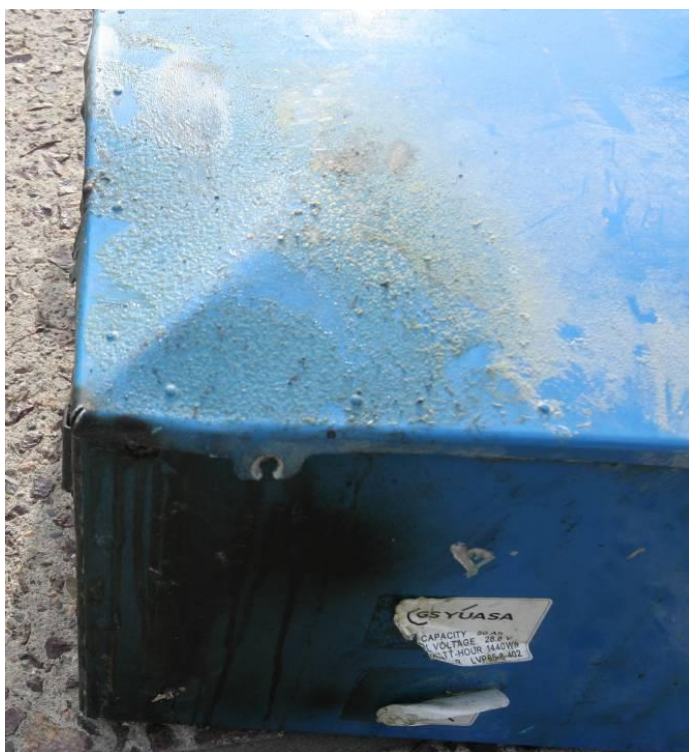
Figure 2: Battery box lid showing deformation, creasing and open seam where the lip edges butt together.

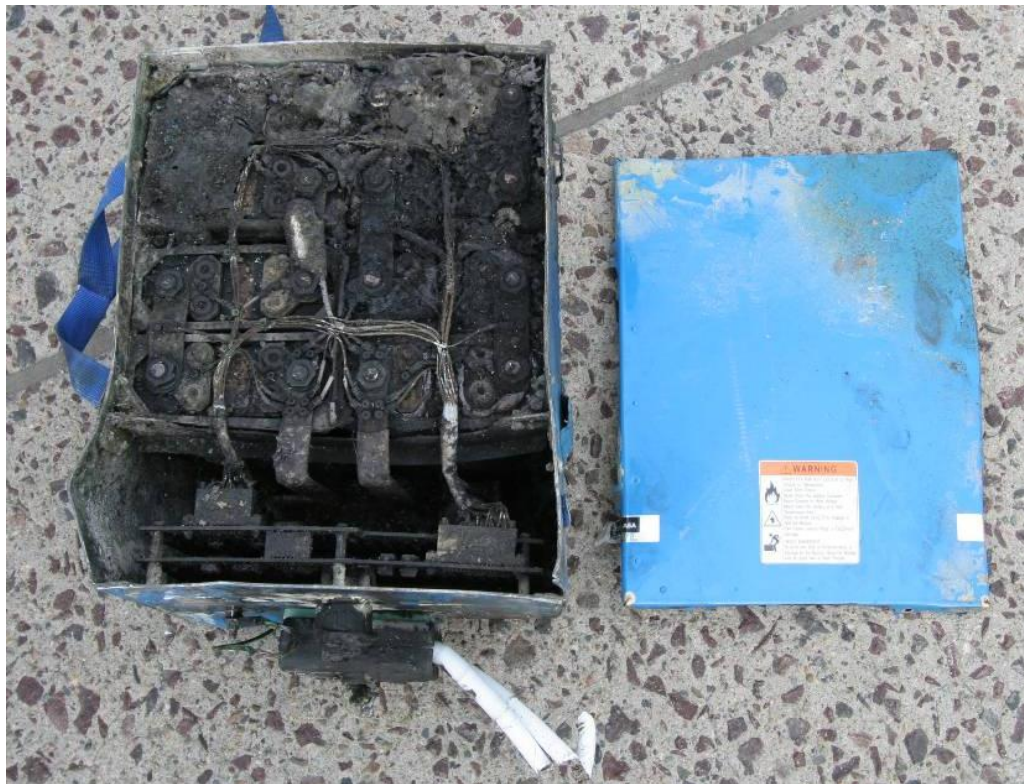
The battery consisted of eight cells, connected in series, and all appear to have vented. There was heavy charring on the tops of the cells with what appears to be the heaviest charring at the right rear corner (A/C¹ left) as viewed from the front (Figure 3). The circuit boards were charred and soot-covered, but physically intact. The internal battery management sense wires were charred but intact. The BPA² thermoplastic polyester sheet that covers the top of the battery cells inside the battery box was charred and melted due to thermal exposure.

Figure 3: Top down view of battery assembly with separated lid set aside.

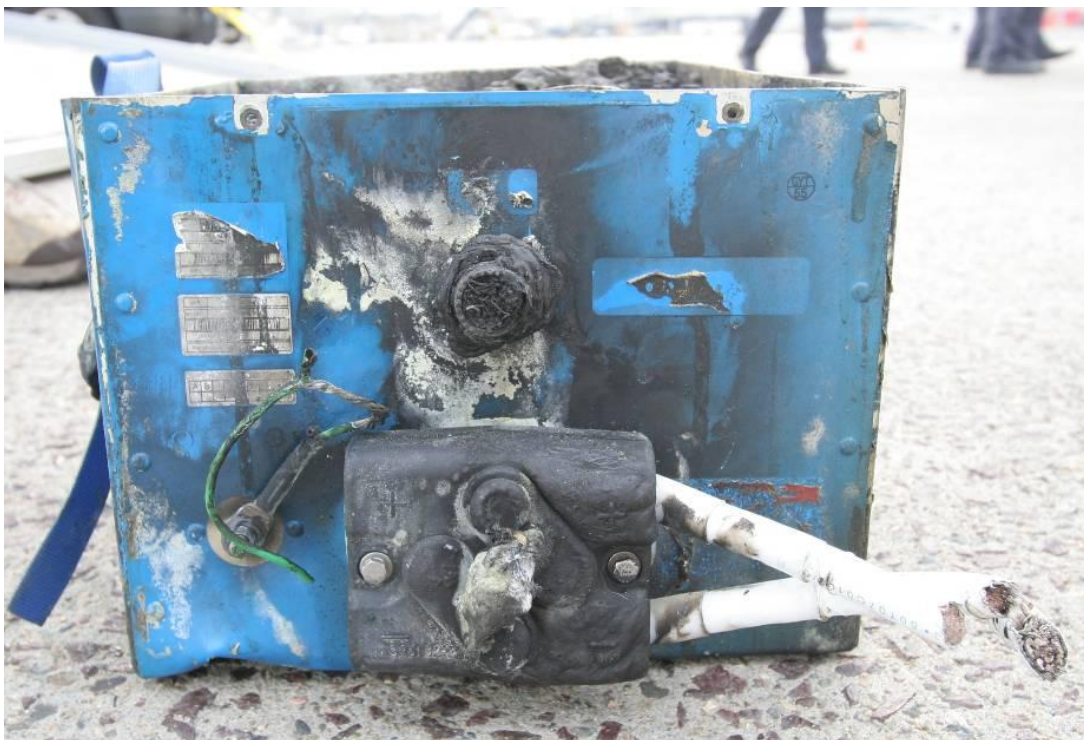
The front battery J3 disconnect latch was melted and inoperable. The front J1 cannon plug connector was also melted (Figure 4).

Figure 4: Side of battery box with electrical connectors.

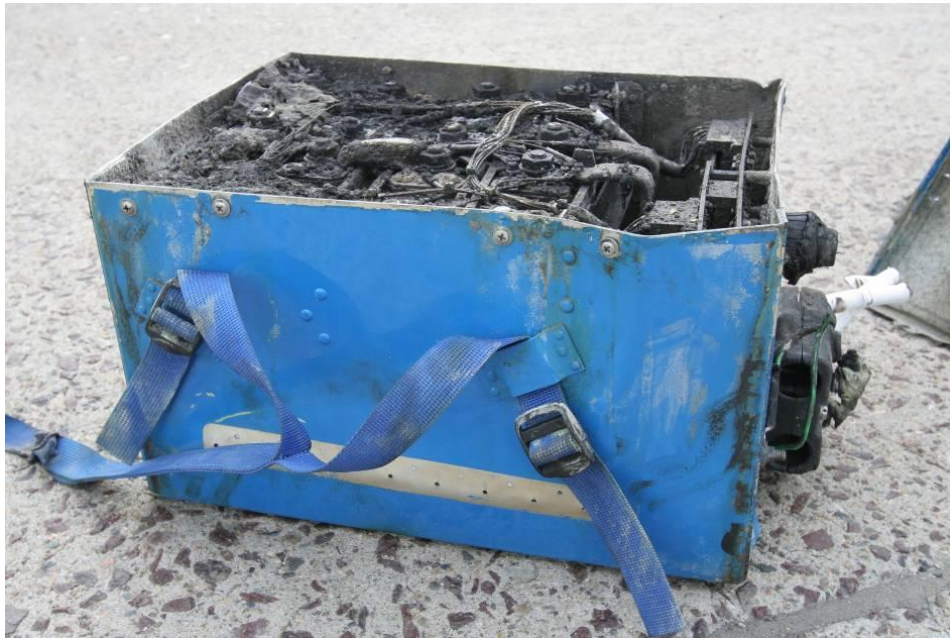
Figure 5: A/C right face of battery box.

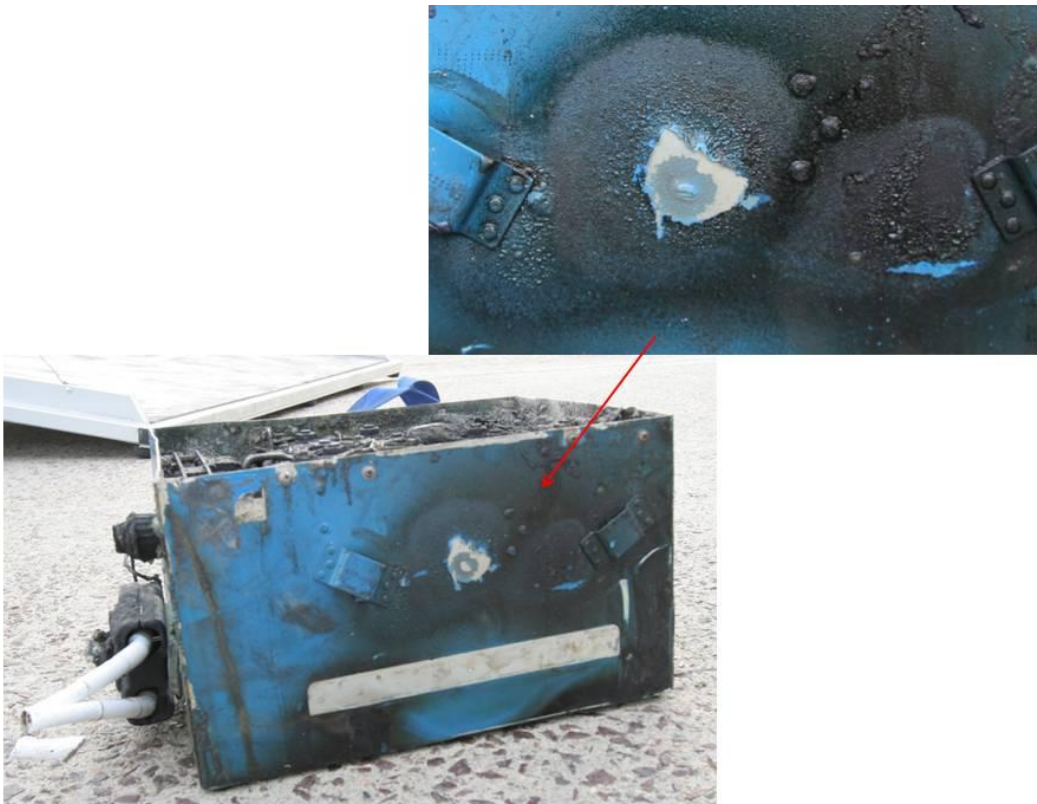
Figure 6: A/C Left face of battery box with inset photo showing area of concentrated thermal damage.

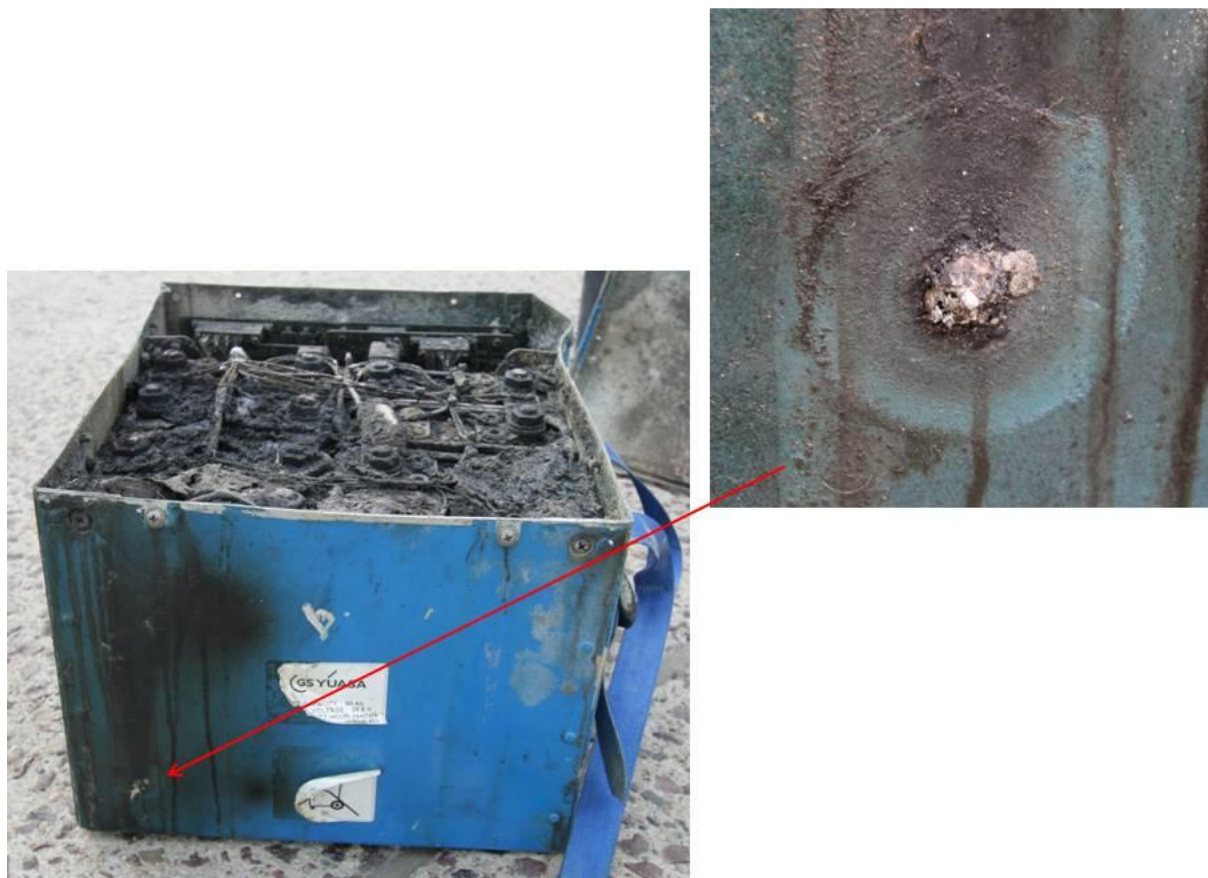
Forward areas of the sides and front of the battery box were kinked, consistent with forceful removal from the aircraft during the fire department’s emergency response. The battery angle mounts on each side of the battery box were forcefully ripped from the sides of the battery box during removal by fire department personnel, shearing the rivets. The angle mounts were still attached to the aircraft. The blue paint on the external battery box was mostly intact, with some areas of charring and soot, primarily on the A/C left sides and back. The A/C right side of the battery had few indications of thermal damage (Figure 5). The A/C left side of the battery box had paint thermally consumed in a spot consistent with the location of a cell vent port (Figure 6). The aft face of the battery box had an unusual feature, a small roughly circular nodular protrusion of about a quarter inch in diameter of what appears to be a melted metallic material, surrounded by a round and concentric area of discoloration (Figure 7).

Figure 7: Aft face of battery box with inset photo showing area of concentrated thermal damage.

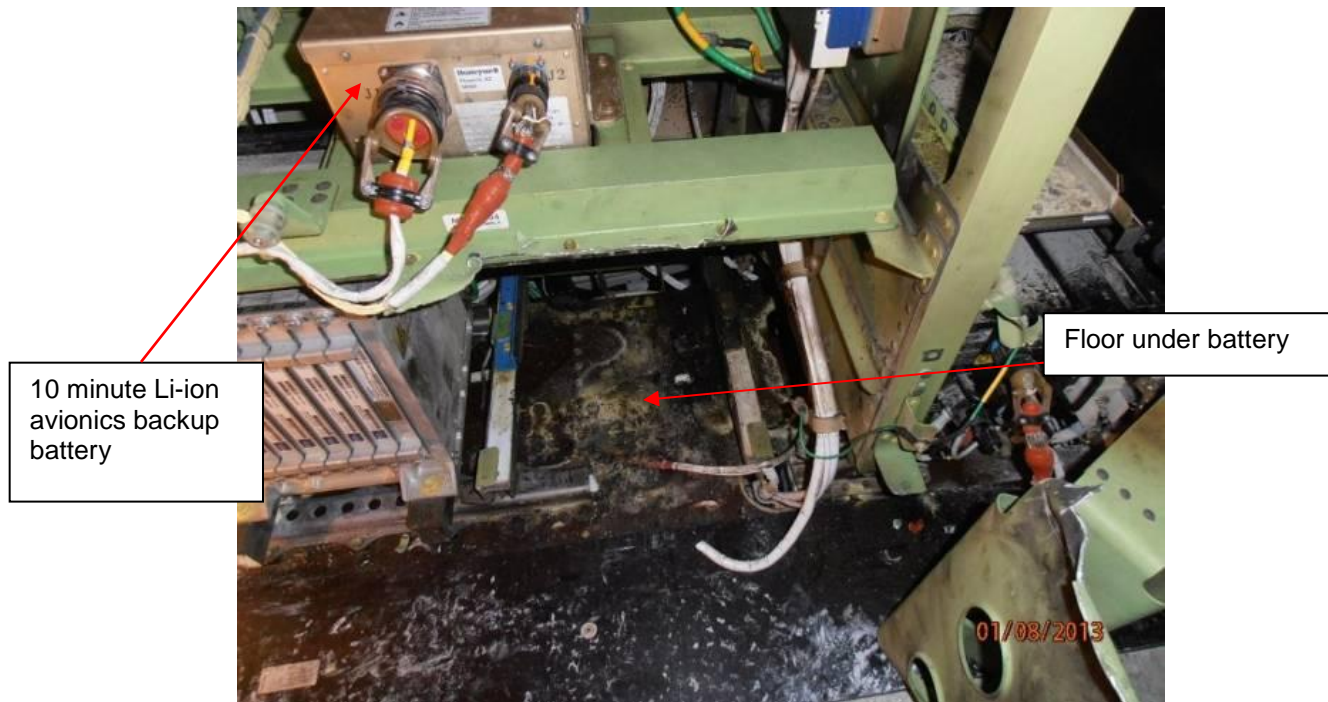
Figure 9: Battery compartment, facing aft in EE bay, after battery removal.

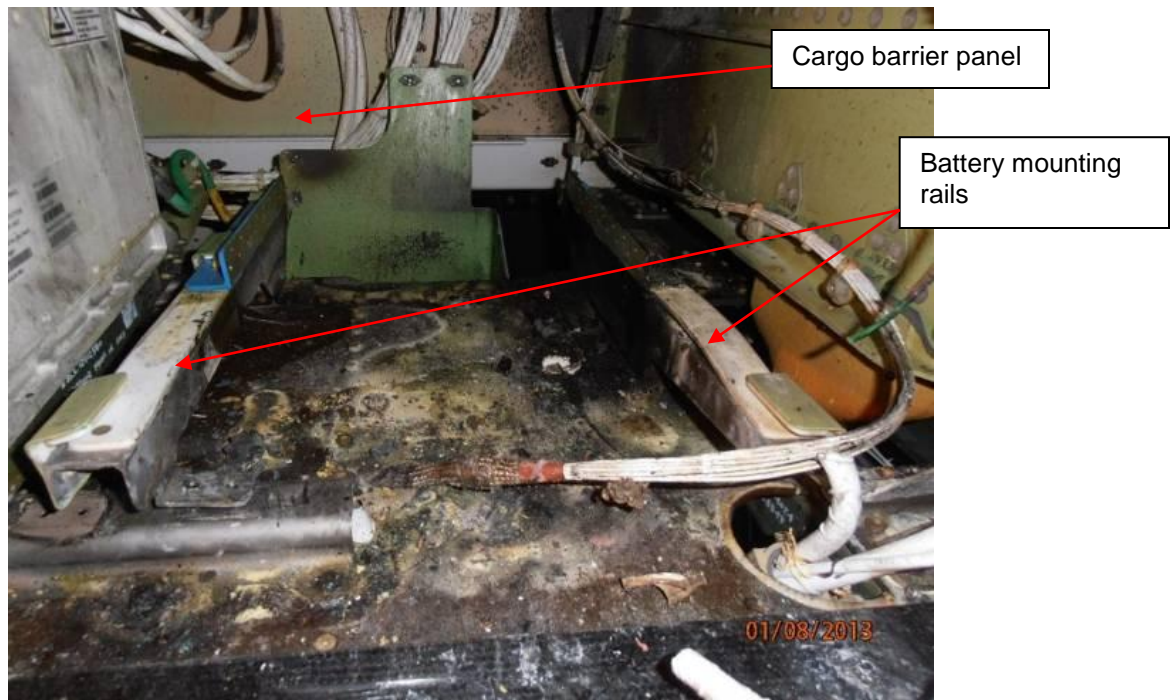
Figure 10: Close up view of battery compartment in aft EE bay.

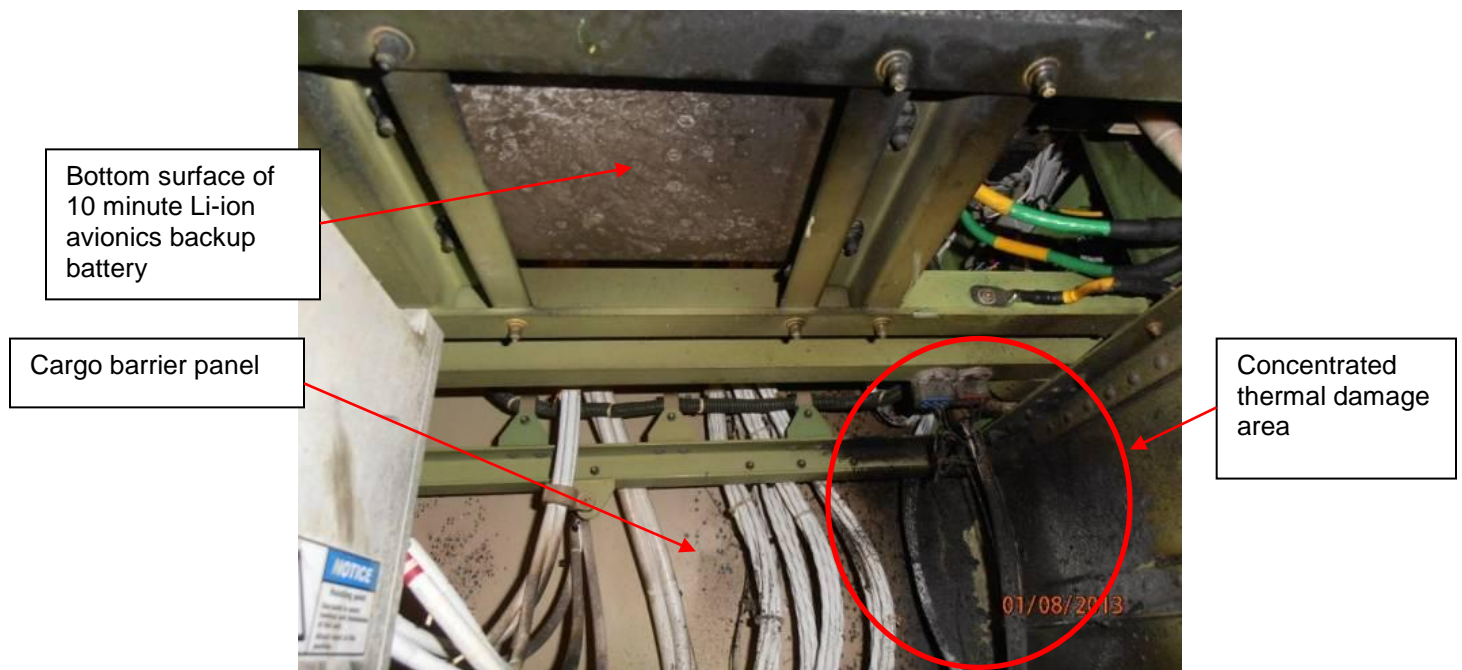
Figure 11: Battery compartment, facing aft, looking upwards.

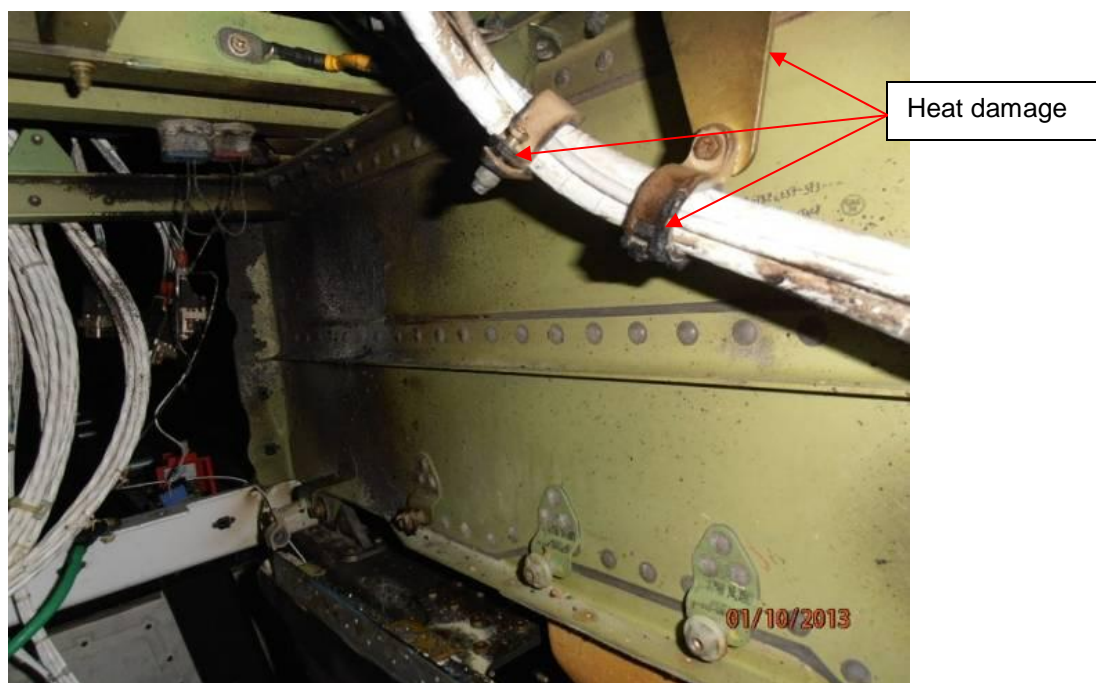
Figure 12: Thermal damage to wiring and clamp on A/C left side of the battery.

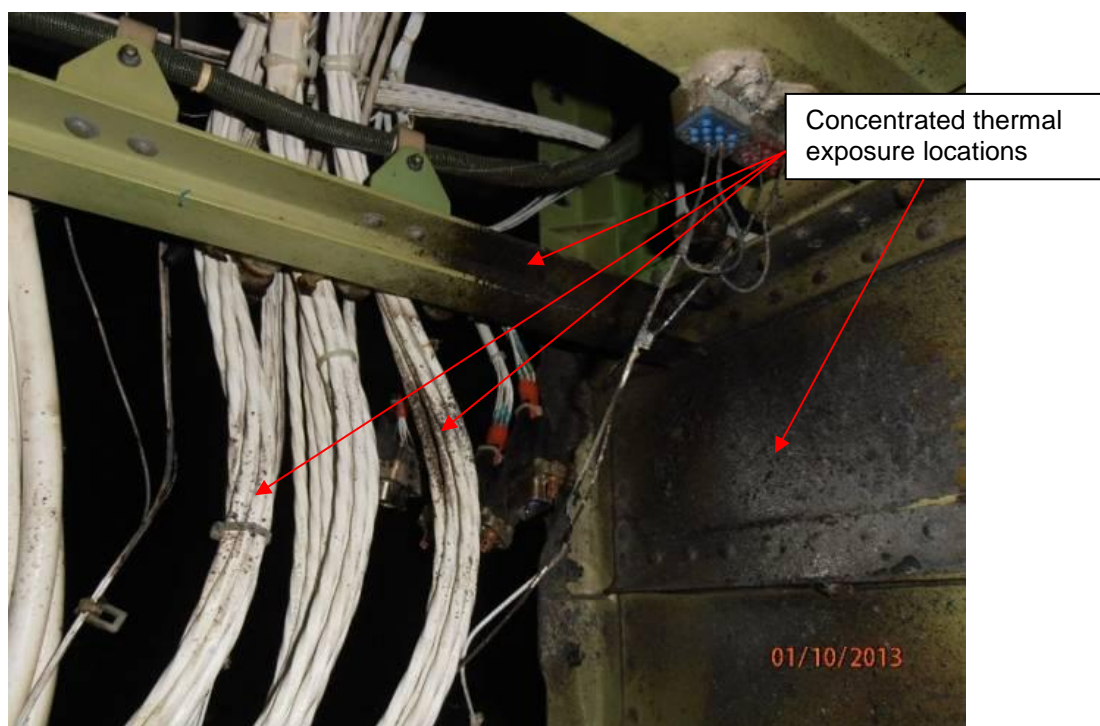
Figure 13: Close-up of battery electrolyte and smoke spray up to the A/C left behind the battery.

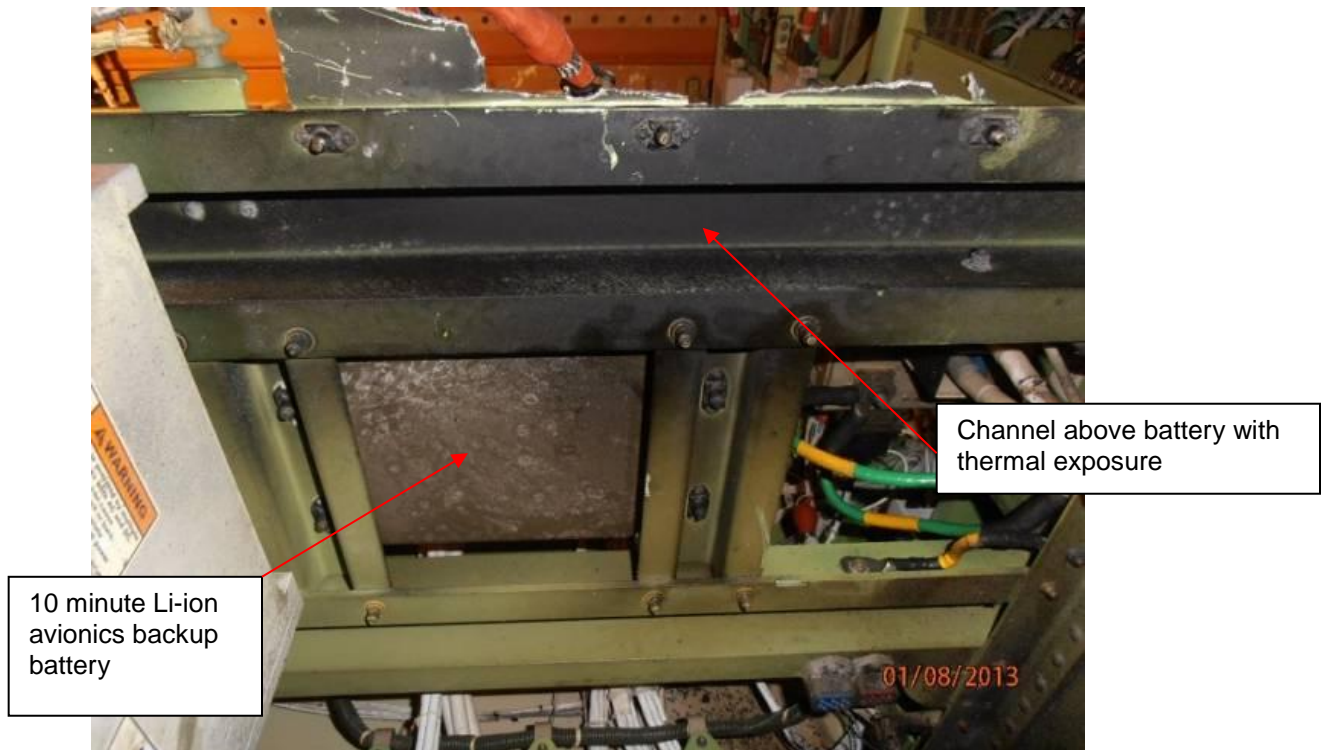
Figure 14: View looking up above battery location

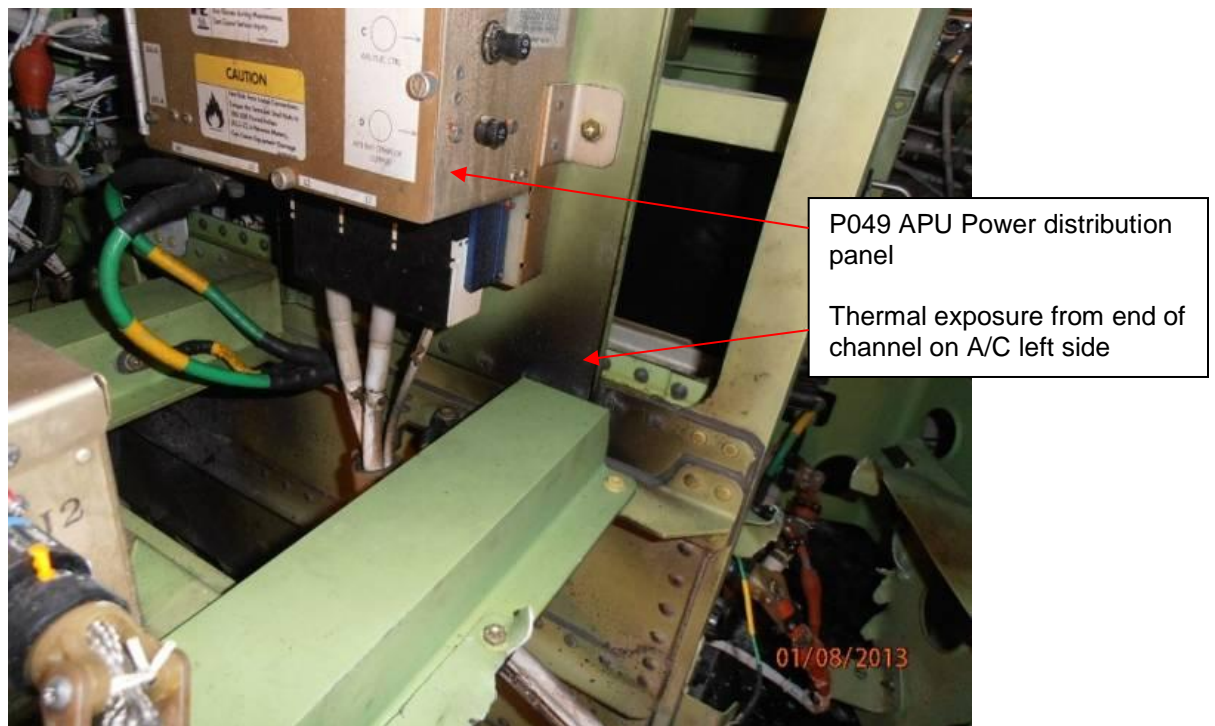
Figure 15: Top side of channel shown in figure 14

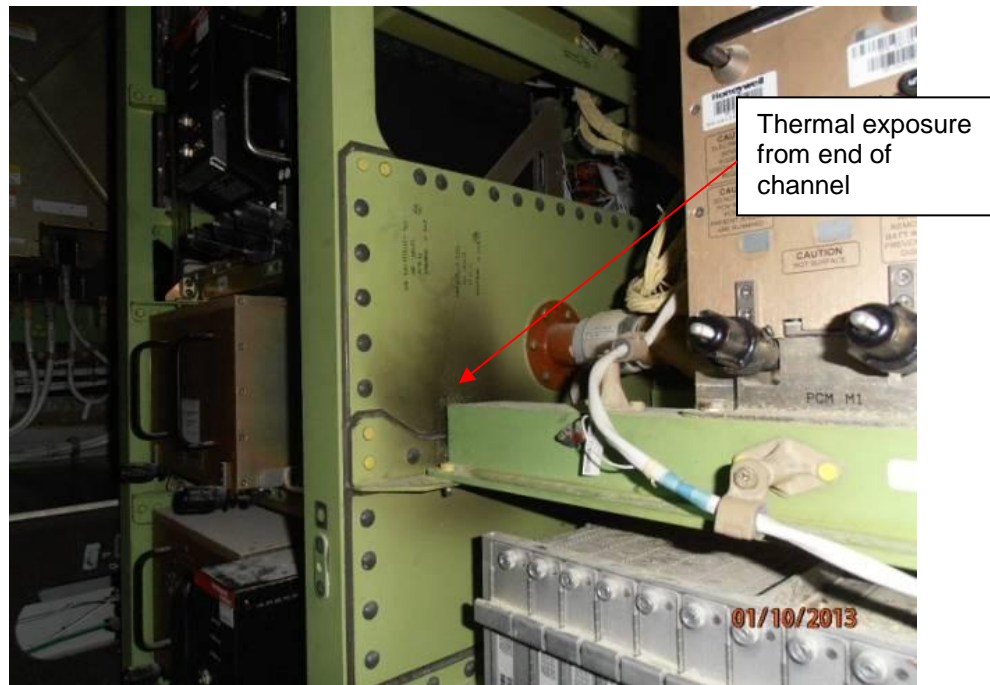
Figure 16: A/C right side of channel looking aft

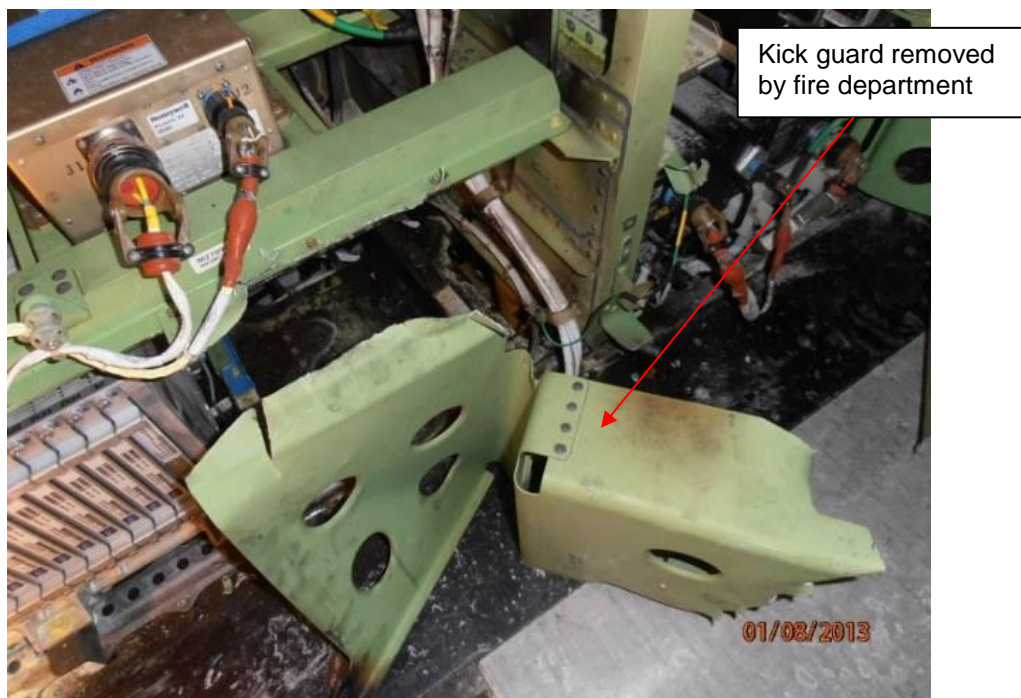
Figure 17: Kick Guard in front of battery compartment

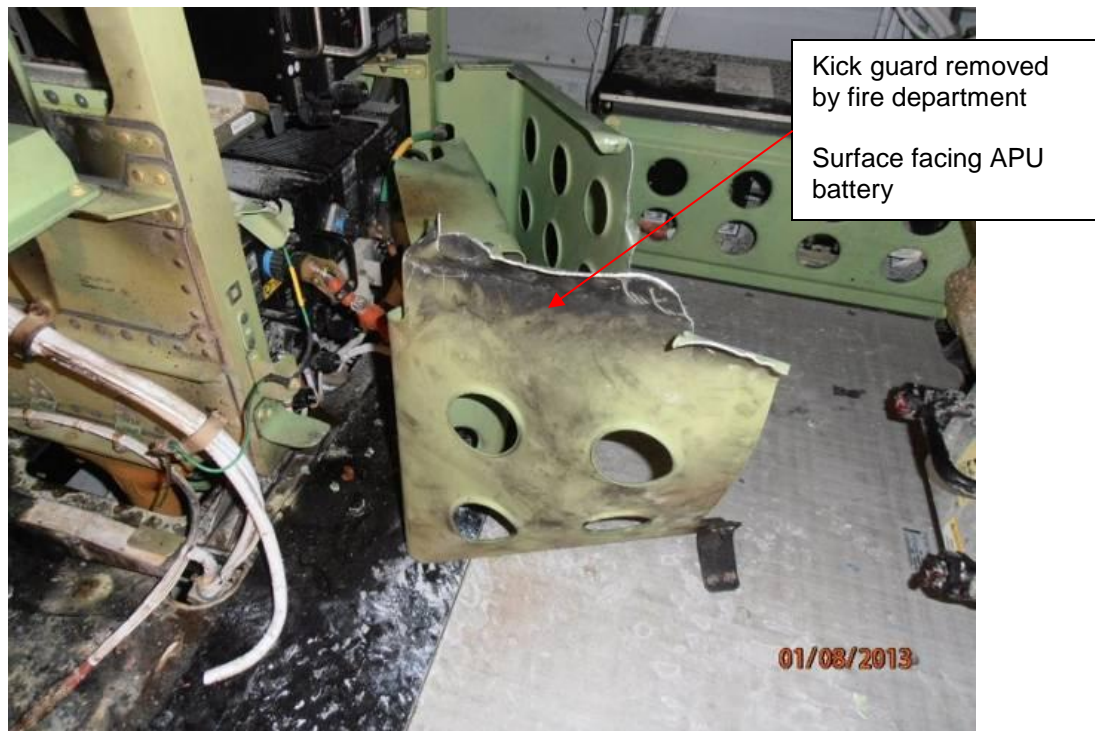
Figure 18: Battery compartment protective (kick guard) shield viewing side facing APU battery.

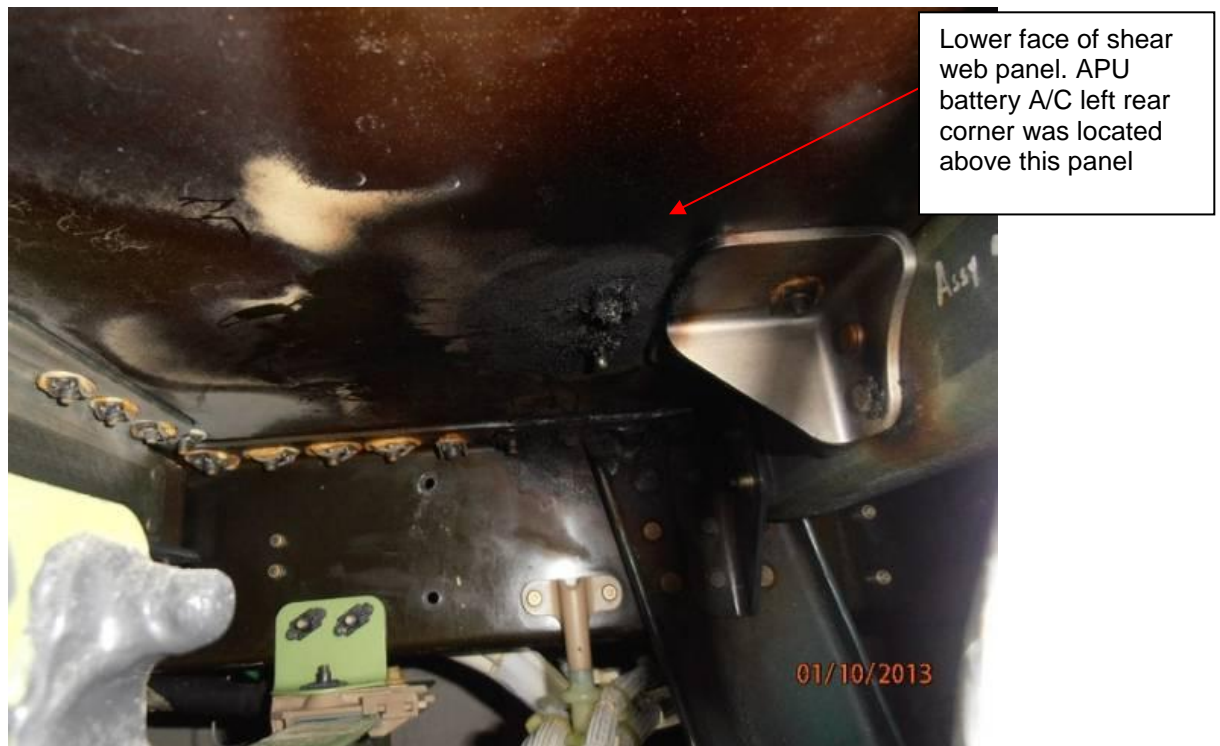
Figure 19: Lower face of panel underneath APU battery compartment.

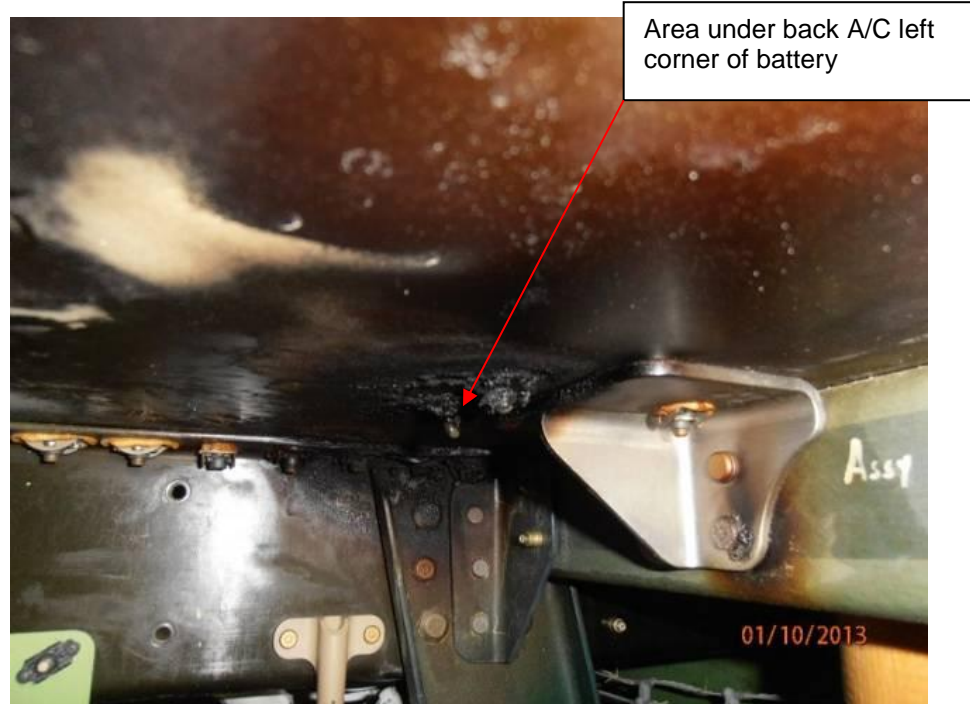
Figure 20: Close-up of photo above showing back A/C left corner under battery.

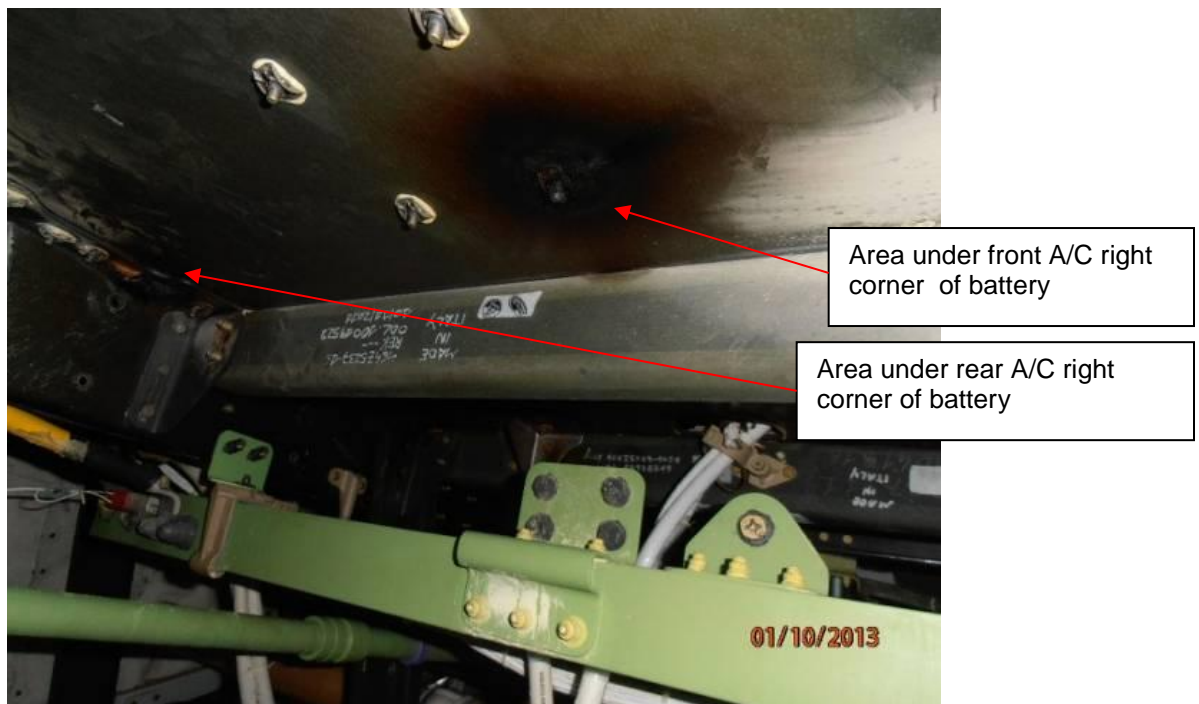
Figure 21: Lower face of panel under battery looking up and back at A/C right side of battery.

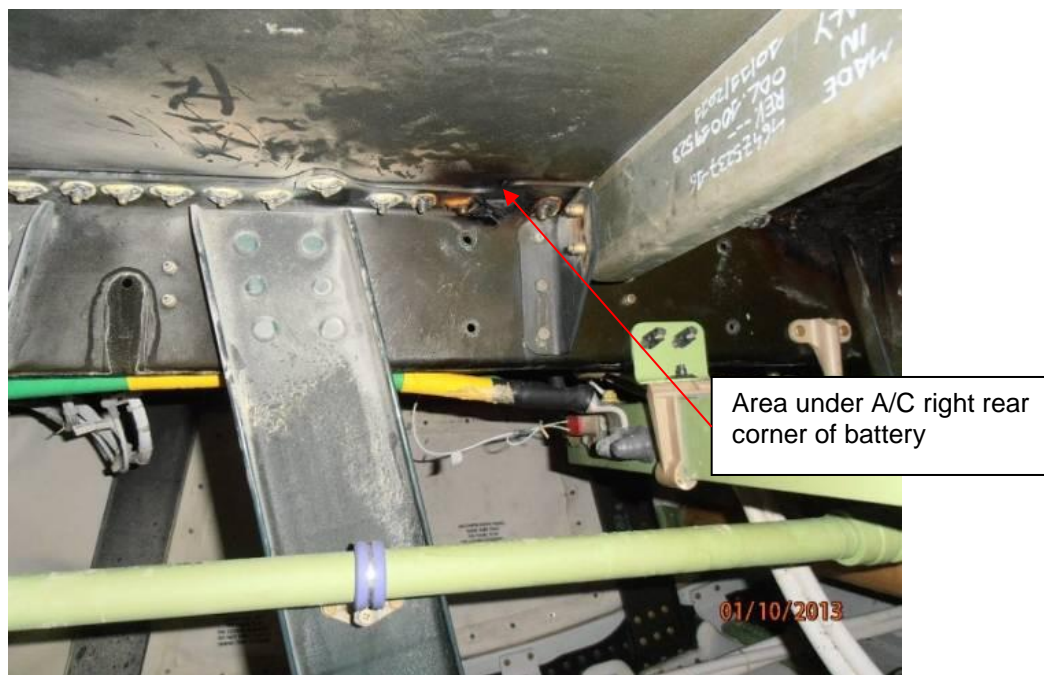
Figure 22: Photo looking towards back A/C right corner of panel under battery.

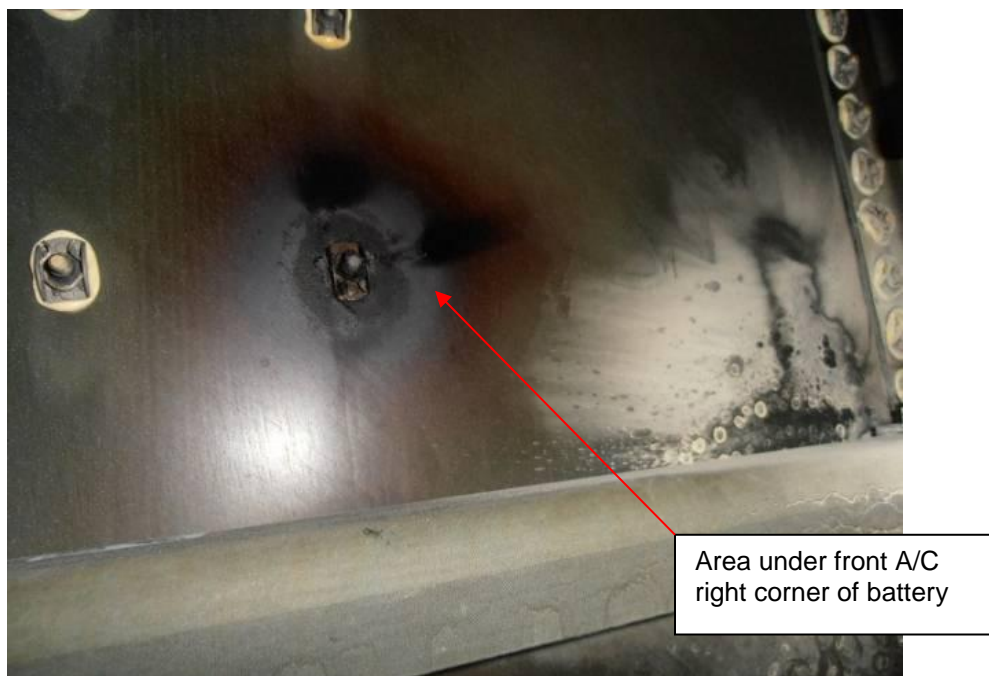
Figure 23: View looking up to forward A/C right corner of panel under battery.

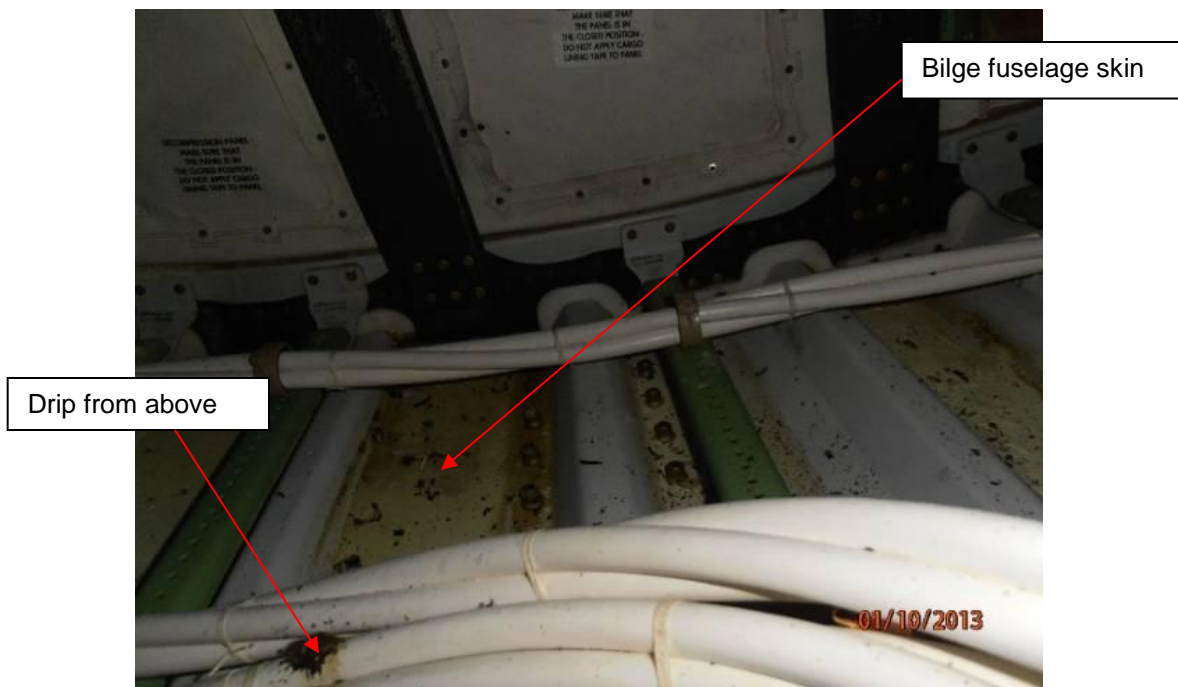
Figure 24: Bilge area under rear of battery panel.

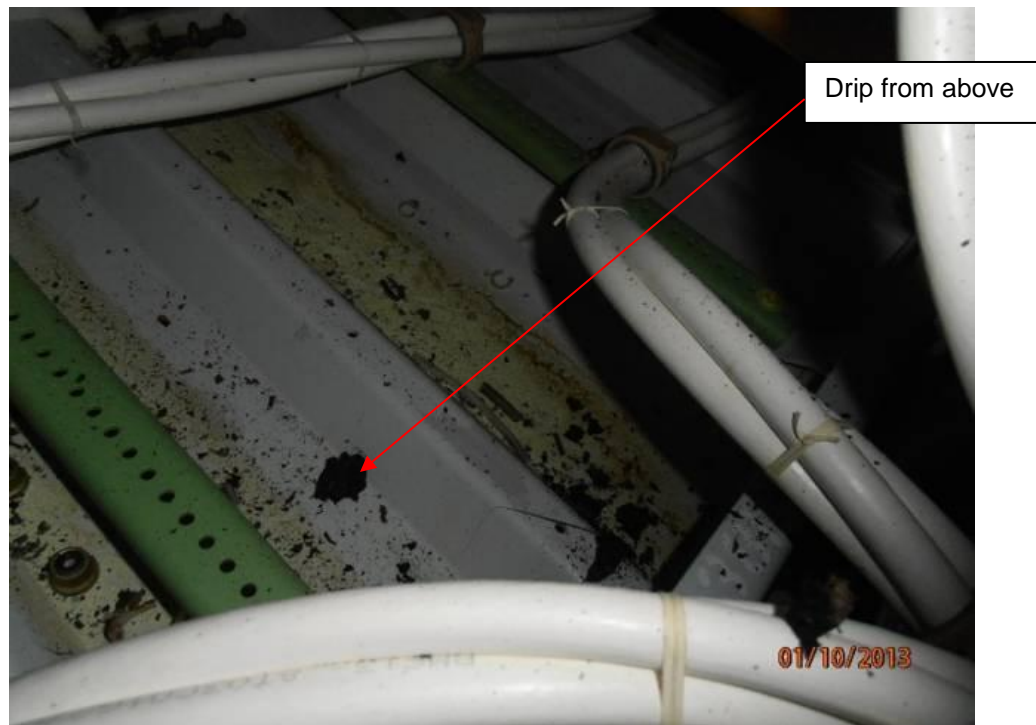
Figure 25: View of bilge area underneath and behind battery compartment.

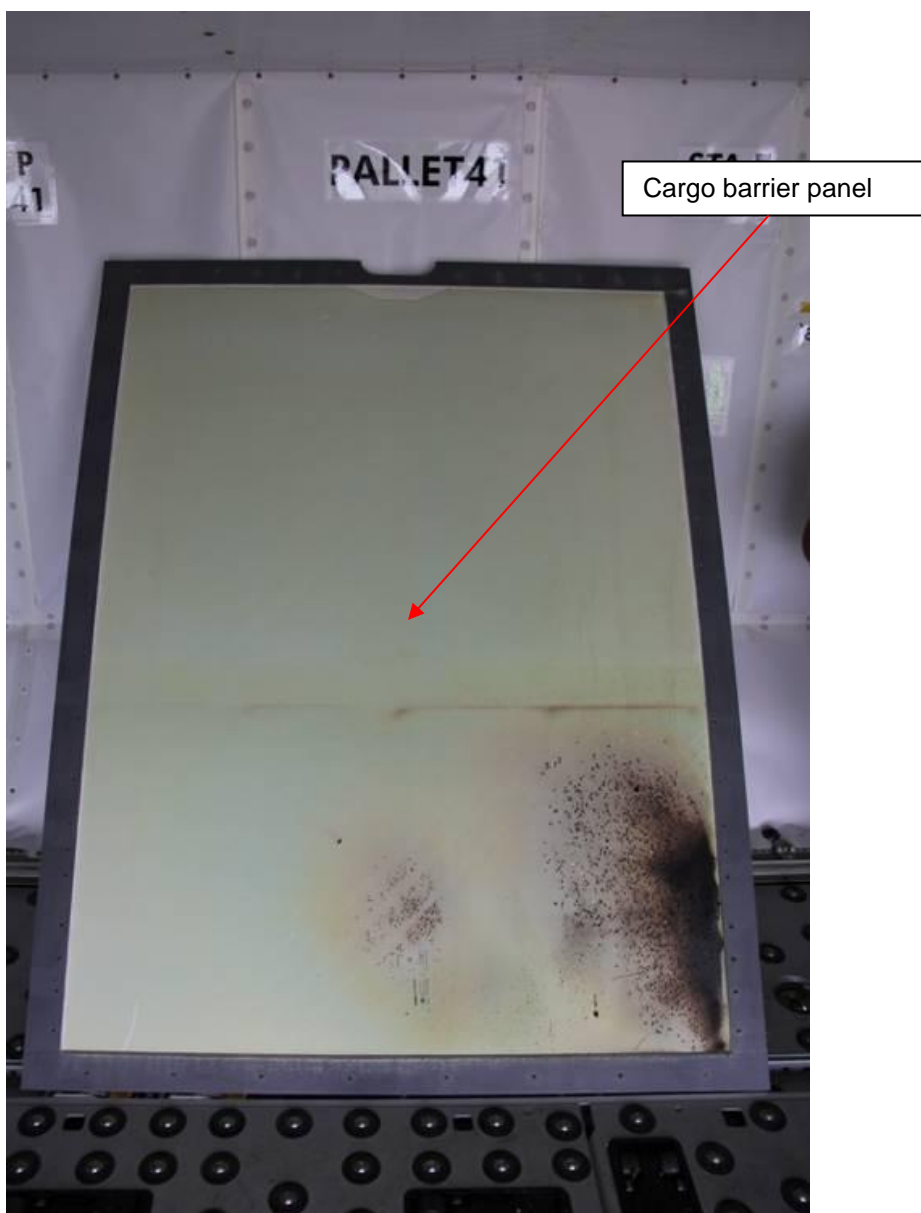
Figure 26: Aft cargo compartment, forward cargo barrier panel, after removal.

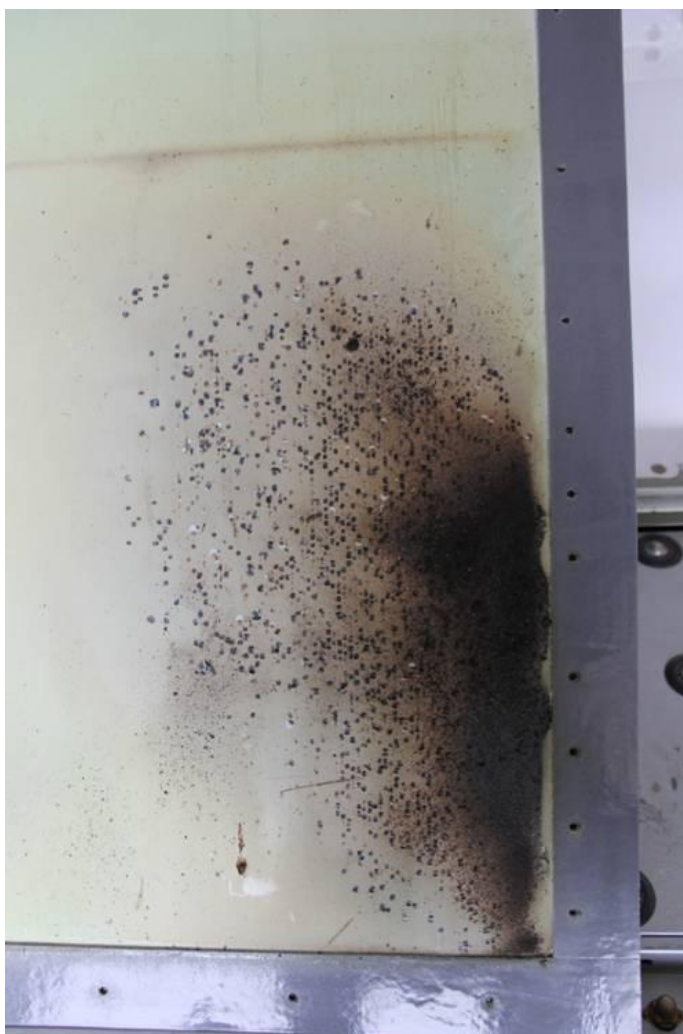
Figure 27: Close up of above view focusing on lower right corner in figure 26. The damage corresponds to the A/C left side of the battery.

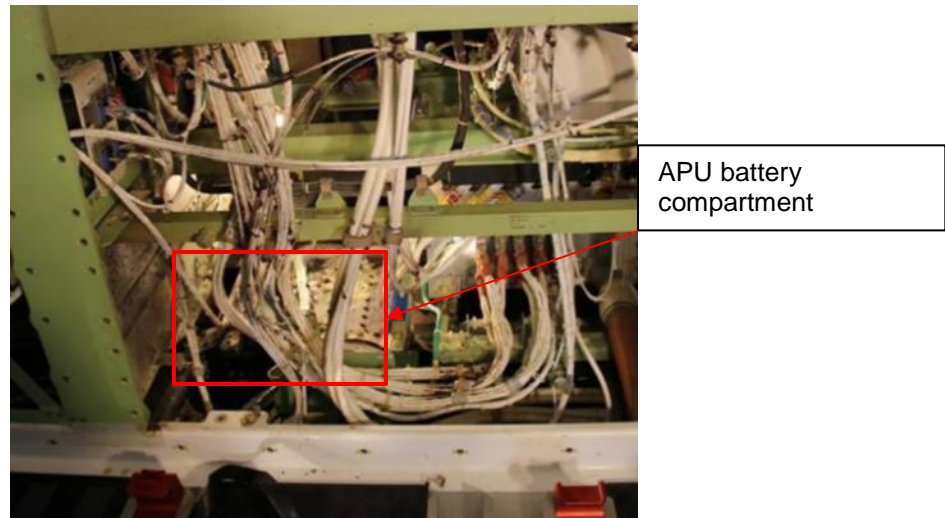
Figure 28: View of the area behind the cargo barrier panel after panel removal, view facing forward taken from inside the aft cargo compartment.

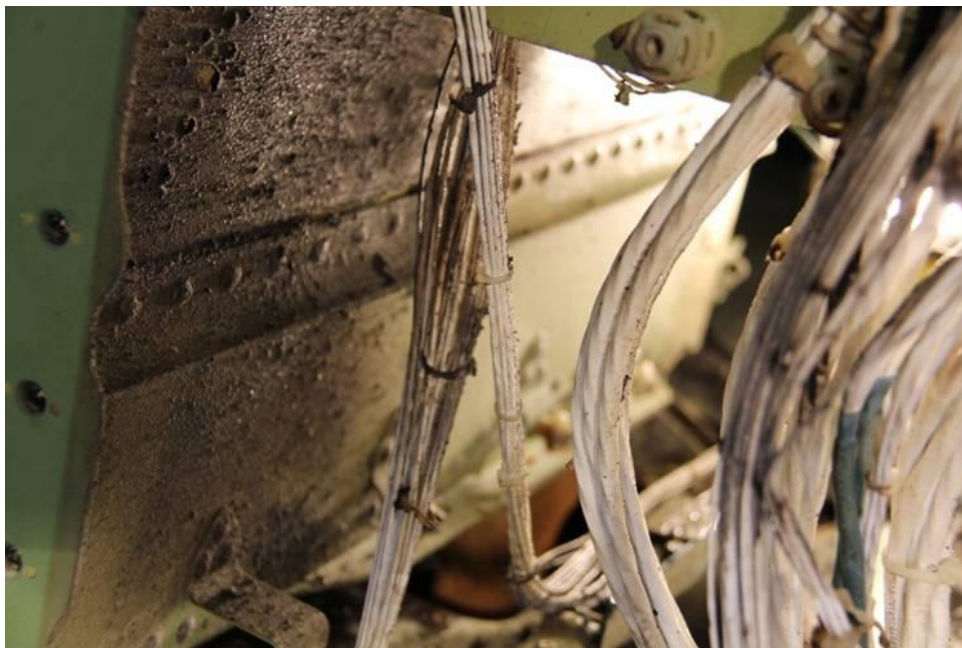
Figure 29: View of lower left of photo above, facing forward taken from inside the cargo compartment, showing spray behind and to the A/C left of the battery.
